Manhole Inspection Summary

Manhole # S13G1_010MH

Record Plat: **13G1** Node: **010** Status: **Other (Specify in comment)** Insp Date: **3/7/08 2:07 PM**

Location Address: **3140 Atco AV**

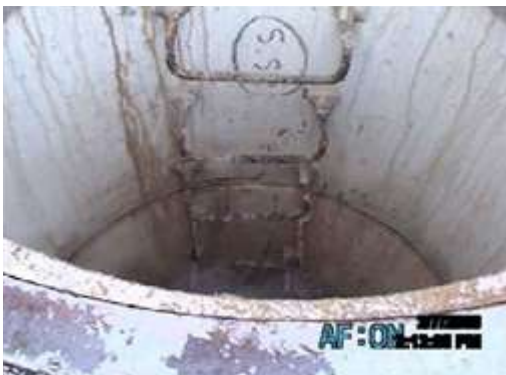
Defect 3

Steps Count: **5** Missing: **0** ☒ **Corroded**

oxidized steps

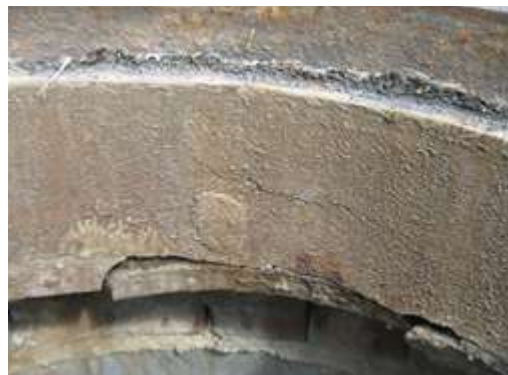
Defect 2

Frame Offset: **0** (in.) Condition: ☐ Sound ☒ **Cracked** ☐ Leaks

cracked frame

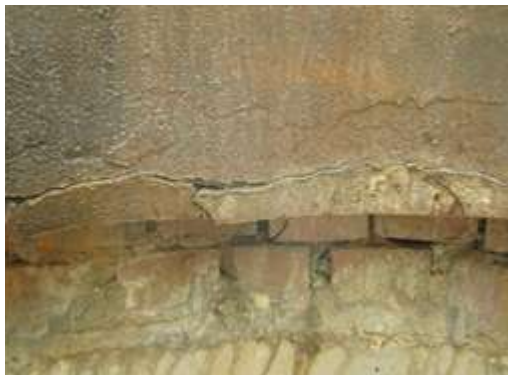
Defect 1

Condition: ☐ Sound ☐ Cracked ☐ Root Intrusion ☐ Loose Brick ☒ **Deteriorated**

Infiltration: ☐ None ☐ Joint ☐ Cracks ☒ **Mortar** ☐ Roots ☐ Wall

chimney deteriorated with infiltration at mortar

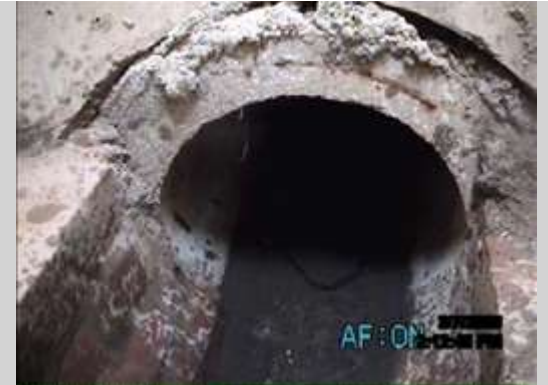
12 O'Clock Outflow

12 in. Circular Gravity Sewer
Pipe Out @ 12 O'Clock

Pipe Height: **12** (in.) Rod and Bar (Angled)
Pipe Material: **Clay** ☐ Pipe Lined
Invert Depth: **7.80** (ft.) Flow Characteristics: **None**
Deposits: ☒ None ☐ Mud ☐ Sludge ☐ Debris ☐ Grease
Silt Depth: **0** (in.) Deposits Extent:
Infiltration: **None** Pipe Seal Cond: **Sound**

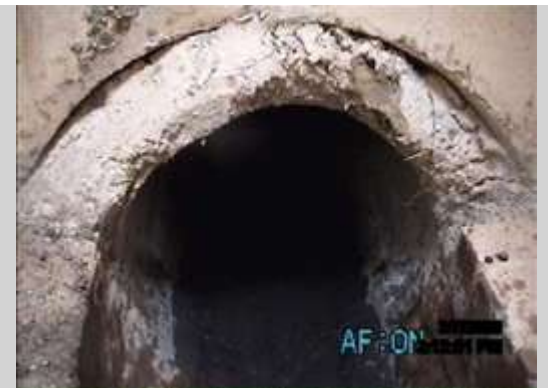
6 O'Clock Inflow

12 in. Circular Gravity Sewer
Pipe In @ 6 O'Clock

Pipe Height: **12** (in.) Rod and Bar (Angled)
Pipe Material: **Clay** ☐ Pipe Lined
Invert Depth: **7.55** (ft.) Flow Characteristics: **None**
Deposits: ☒ None ☐ Mud ☐ Sludge ☐ Debris ☐ Grease
Silt Depth: **0** (in.) Deposits Extent:
Infiltration: **None** Pipe Seal Cond: **Sound**
